# THE SURFACE WATER STORAGE PROBLEM IN ARID REGIONS: A CASE STUDY OF THE GARGAR DAM, ALGERIA

H. Benfetta<sup>1\*</sup>, A. Ouadja<sup>2</sup>

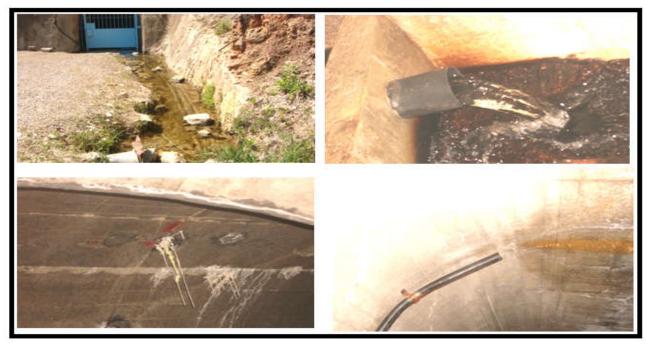
Fig.7. Leaks in the banks of the Gargar dam (Source: Benfetta 2008)

Figure 7 shows leakages. The upstream body of water at the foot of the dam is separated from the basin by a batardeau. Although leaks are observed in the joints of the injection and drainage galleries of both banks, they are much more significant in right bank. This is because the right bank is in contact with the reservoir, while the left bank is in contact with the body of water located upstream of the dam. Leakage in the two galleries increases as a function of rises in the reservoir level and decreases due to sealing after a long period [3] [14]. Some leaks are sealed by the adhesion of molten limestone. The initial design of the dam did not include any devices to measure such leakage. These leakages are also due to the presence of a strong hydraulic gradient. However, the increase of this rate in time and for the same water level of the lake indicates deterioration of the rock mass forming the support of the dam. The rate of leakages was almost on the increase in time and especially when the water level in the reservoir is above the coast 98 m. This could be explained by the fact that the increased hydrostatic pressure resulted in a deterioration of the bedrock by the appearance of large cracks. It's due to the degraded state of the geological layers. The current solution is to record the flow rate at the exit points of galleries in the right and left bank. Additional test points would enhance the reliability of measures and make it possible to differentiate leaks in the various galleries (injection, drainage and access). It is also important to observe the progress of cracks, which can expand if the reservoir level rises (due to increased water pressure) [3].

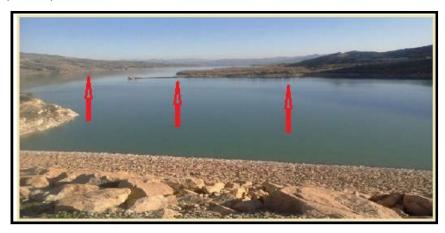
Fig.18. Evaporation at the Gargar dam: source: Benfetta 2008
