# THE SURFACE WATER STORAGE PROBLEM IN ARID REGIONS: A CASE STUDY OF THE GARGAR DAM, ALGERIA

H. Benfetta<sup>1\*</sup>, A. Ouadja<sup>2</sup>

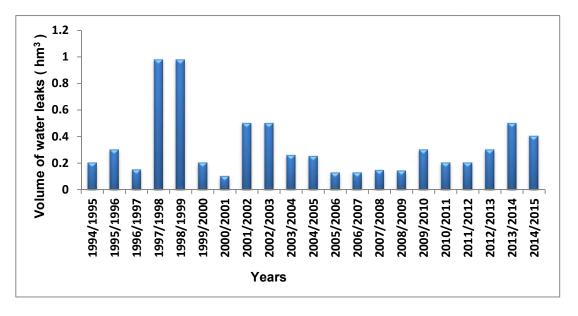
The first analysis concerned the volume of leakage through a study of variations overtime and as a function of the reservoir level. Figure 8 shows leakage estimated by the ANDT for the period 1994–2015 and highlights significant variation. Average annual loss is  $0.3 \text{ hm}^3$  /year. The problem is ongoing, and changes from one year to another. Figure 9 shows variation in leakage as a function of the reservoir level, and highlights the close correlation ( $R^2 = 0.98$ ). The second part of the study analyzed leakage flow rates (l/s) for 2004–2008 (fig 10, 11 and 12) and as a function of the reservoir level (fig 13). Figures 10 and 11 show data for the hydrological years 2005–2006; figures 10, 11 and 12 are discussed in more detail below.

Fig.8. Leakage (hm<sup>3</sup>) 1994–2015: Source: own elaboration

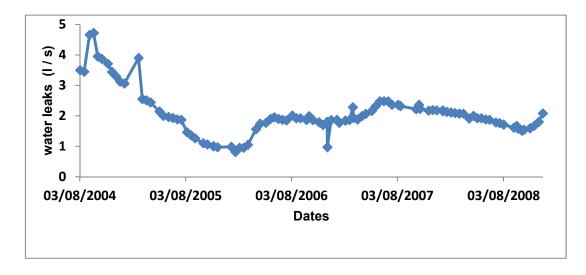
Figure 10 shows that the flow rate through the left bank exceeded 4.3 l/s in February 2004, reaching 5.98 l/s in May 2004. The flow rate subsequently fell, due to the reduction in the volume of water in the reservoir, reaching 0.81 l/s in January 2006. Figure 11 shows that the flow rate through the right bank exceeded 4.6 l/s in February 2004, reaching 5.98 l/s in May 2004. Like the left bank, the reduction in the volume of water in the reservoir led to a significant fall in the flow rate, reaching 2.25 l/s in November 2006. Figure 12 shows total leakage flow rates. This follows trends for each bank. A minimum value 8.5 l/s was recorded in February 2004, reaching 12 l/s in May 2004. Like the two banks, levels subsequently fell due to falling water levels in the reservoir, reaching 2.18 l/s in January 2008.

**Fig.10.** Left bank leakage flow rate (litres/ second) 2004–2008: source: own elaboration

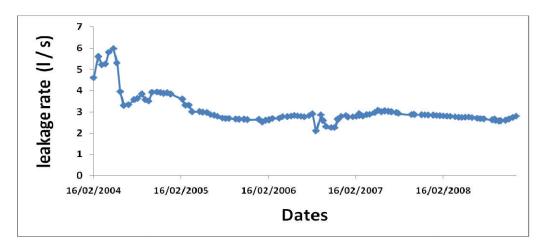
Fig.11. Right bank leakage flow rate(litres/ second) 2004–2008: Source: Own elaboration

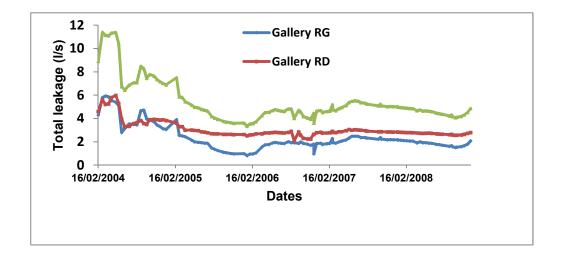
Fig.12. Total leakage flow rate (litres/ second) 2004–2008: Source: Own elaboration

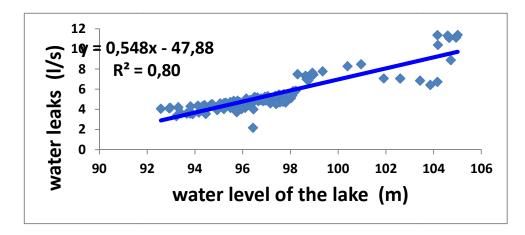
Figure 13 shows variation in flow rate as a function of the reservoir level for all hydrological years. Flow increases linearly with the water level. The two highest correlation coefficients (0.80 and 0.90) were calculated for the hydrological years 2004–2005 and 2005–2006 (fig 14 and 15). Figure 13 shows that flow rates increase consistently up to a reservoir level of 98 m, beyond which there is a more rapid increase. This could be explained by the fact that up to 98 m, flow is governed by Darcy's law and depends on the permeability of the massif. Above 98 m, underground flows no longer follow this law and instead pass through highly permeable layers or faults. This increase was particularly remarkable for the hydrological years 2004–2005 and 2005–2006. Increasing hydrostatic pressure, due to the progressive increase in the reservoir level resulted in a notable decrease in load. This resulted in the deterioration of the rock massif at the dam site, which translated into significant cracks [3] [4] [5].

**Fig.13.** Leakage (litres/ second) as a function of reservoir level (metres): source: Own elaboration

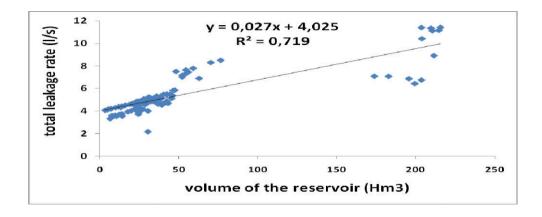
Figure 16 shows the variation of the volume of the reservoir from 2004–2008. Overall, the volume falls to drought conditions. Furthermore, Figure 17 shows how leakage falls as a function of the reservoir's volume and shows that low rates are closely correlated ( $R^2 = 0.72$ ).

**Fig.17.** Leakage (litres/ second) as a function of reservoir volume (hm<sup>3</sup>): Source: Own elaboration

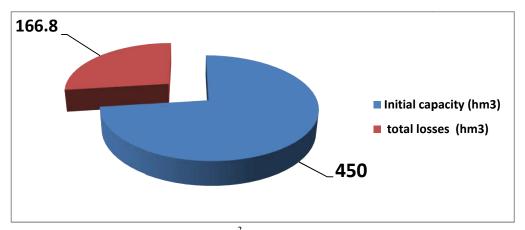
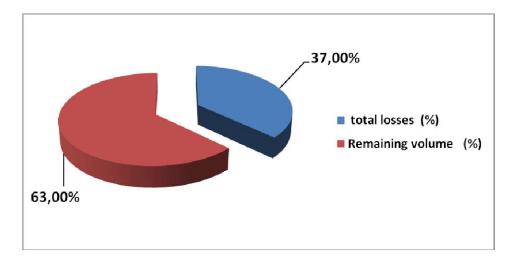
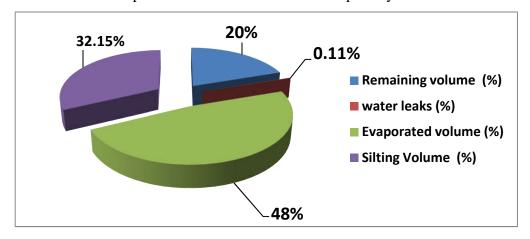
This makes a total loss of 166.8 hm<sup>3</sup>, representing about 37% of total capacity (fig 24, 25 and 26). The most important factors are leakage and sedimentation, which has reduced capacity to a remarkable extent. These problems must be addressed as a priority.

Fig.24. Percentage water losses by sector 1988–2015: source: own elaboration

Fig.25. Total water losses (hm<sup>3</sup>)1988–2015: source: Own elaboration

Fig.26. Total water losses (%) 1988–2015: source: own elaboration
